## Fluvial Processes and Channel Stability of the Torsa River, West Bengal (India)

Fluvial processes such as bank erosion plays an important role to change the channel stability of the Torsa River in the downstream region. The present study was focused on stream stability assessment of the Torsa River. The study area is situated between the downstream of the Jaldapara Reserve Forest and confluence of Kaljani River. Data of different parameters about 64 bank segments of the Torsa River were prepared using the field work techniques for assessing the stream bank conditions using lateral, vertical and overall reach stability models. The individual results of BEHI and NBS ratings show that out of 64 bank segments only 35 and 19 bank segments classified in higher categories. Overall lateral stability analysis shows that most of the sample bank segments are in an unstable condition. All bank segments are vertically unstable and degrading. Overall reach stability analysis shows widespread instability. BEHI and NBS results are almost similar for most of the bank segments and therefore, BEHI and NBS can be suitable bank erosion hazard predictive models in the study for channel stability ana

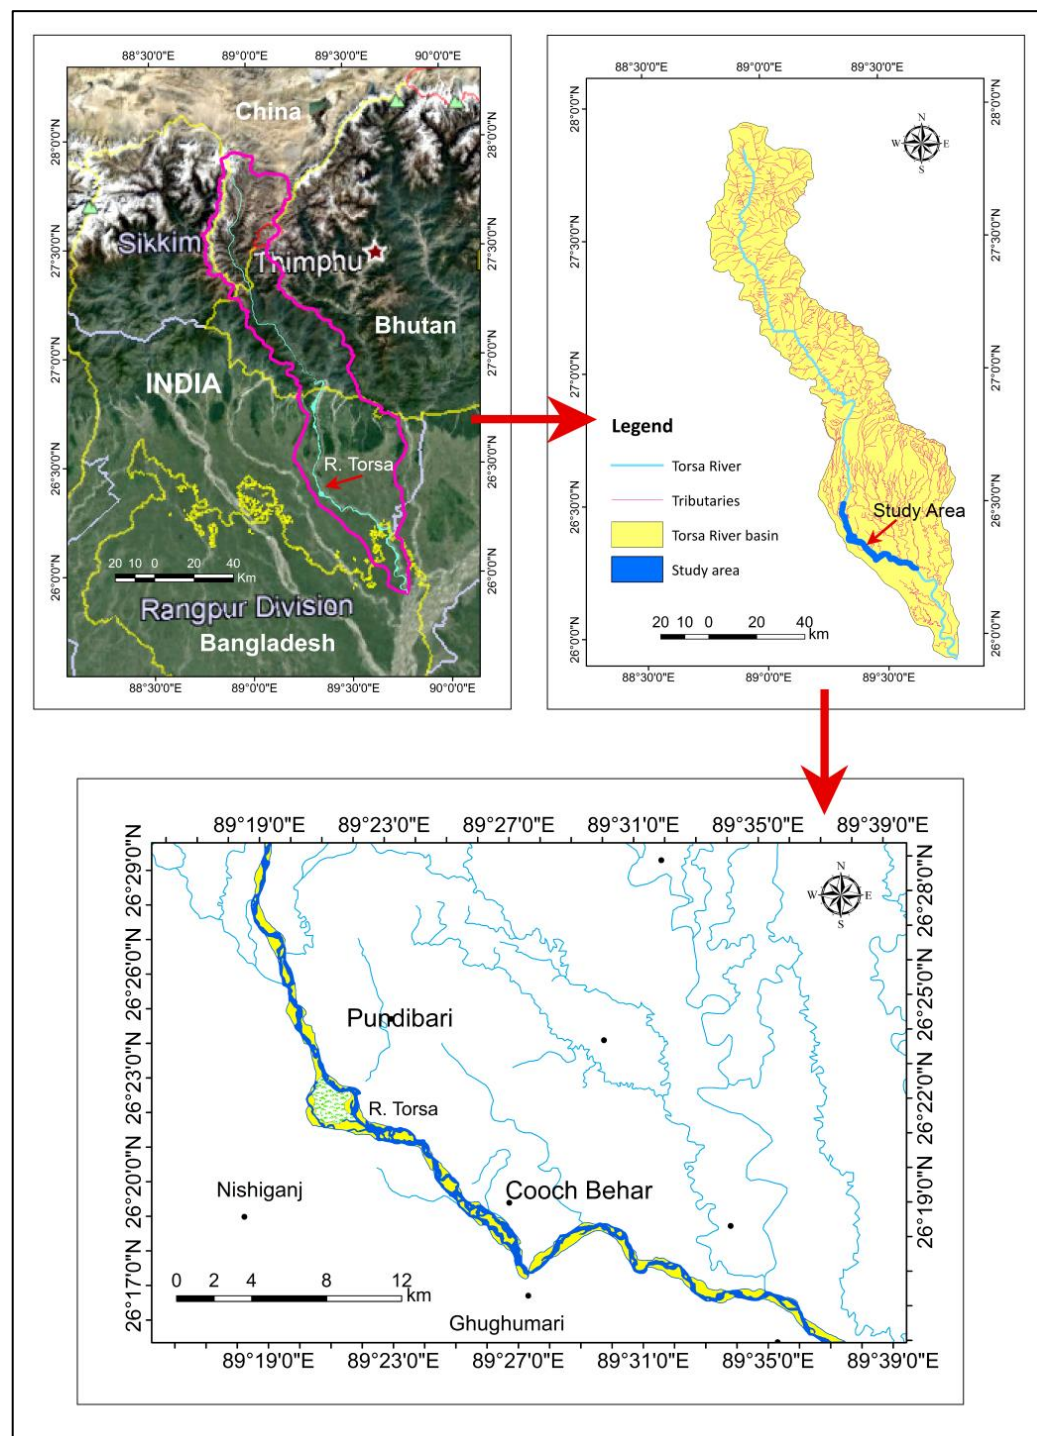
Figure 1. Study area

Mandal, 2018a). Most part of the study area is characterized by medium to fine sands, loam, clay and alluvium soils (Figure 1). The region is interspersed with several swamps, oxbow lake, natural levees and Paleochannels (Dey and Mandal, 2018b). The area of the present study is located between the downstream of Jaldapara reserve forest (26°30' 0.09"N, 89°19' 20.3"E) and confluence of Kaljani river (26°15' 0.11"N, 89°37' 01.19"E) (Figure 1). The study area includes three Blocks (Mathabhanga-II, Cooch Behar-I, Cooch Behar-II, Tufanganj I and one urban center i.e. Cooch Behar municipality which is suffering from flood and bank erosion severely (Dey and Mandal, 2018b).

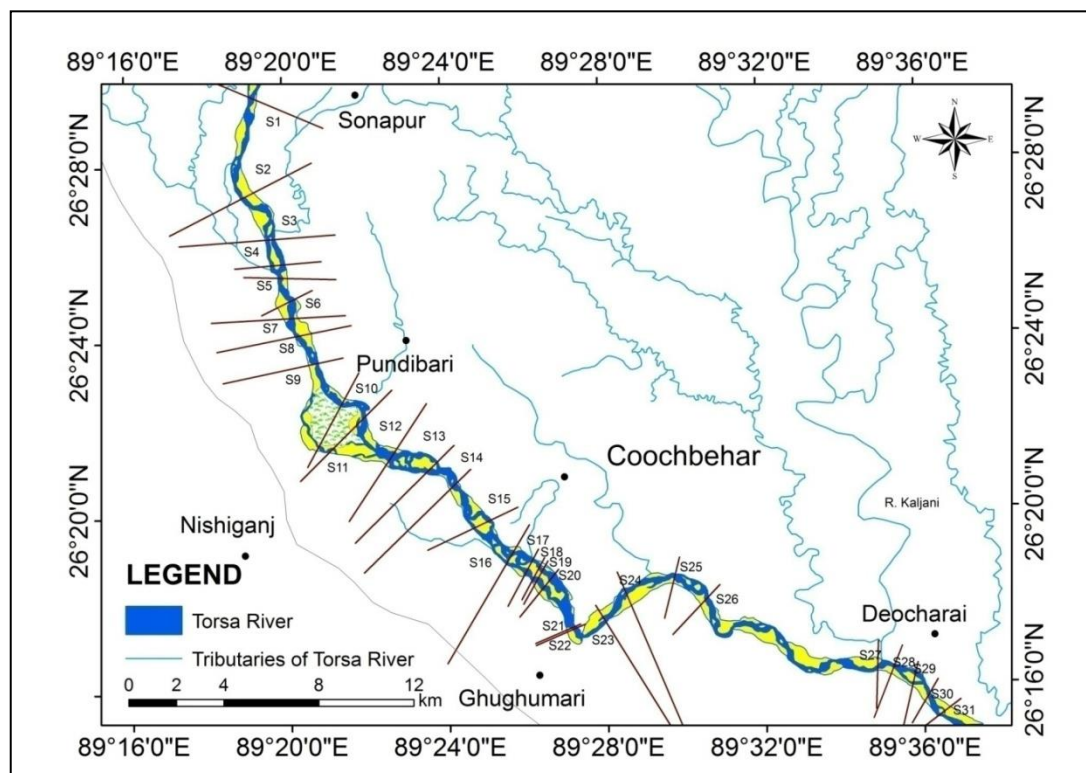
Figure 2. Cross sections across the Torsa River

Thirty-two cross sections were selected to derive data from 64 sites using field survey for determining the channel stability of the Torsa River with the help of various measuring instruments: GPS, leveling staff, Eco-sounder, digital water current meter, clinometer and dumpy level (Figure 2). Profiles of the stream banks were overlaid to determine the toe-pin area changes due to the processes of erosion. The vulnerability map of the Torsa River through image processing was performed in ArcGIS Software version 10.3.1. Various data have been generated from the field for assessment of stream stability viz. vertical stability, lateral stability, and overall reach stability (Starr, 2009).

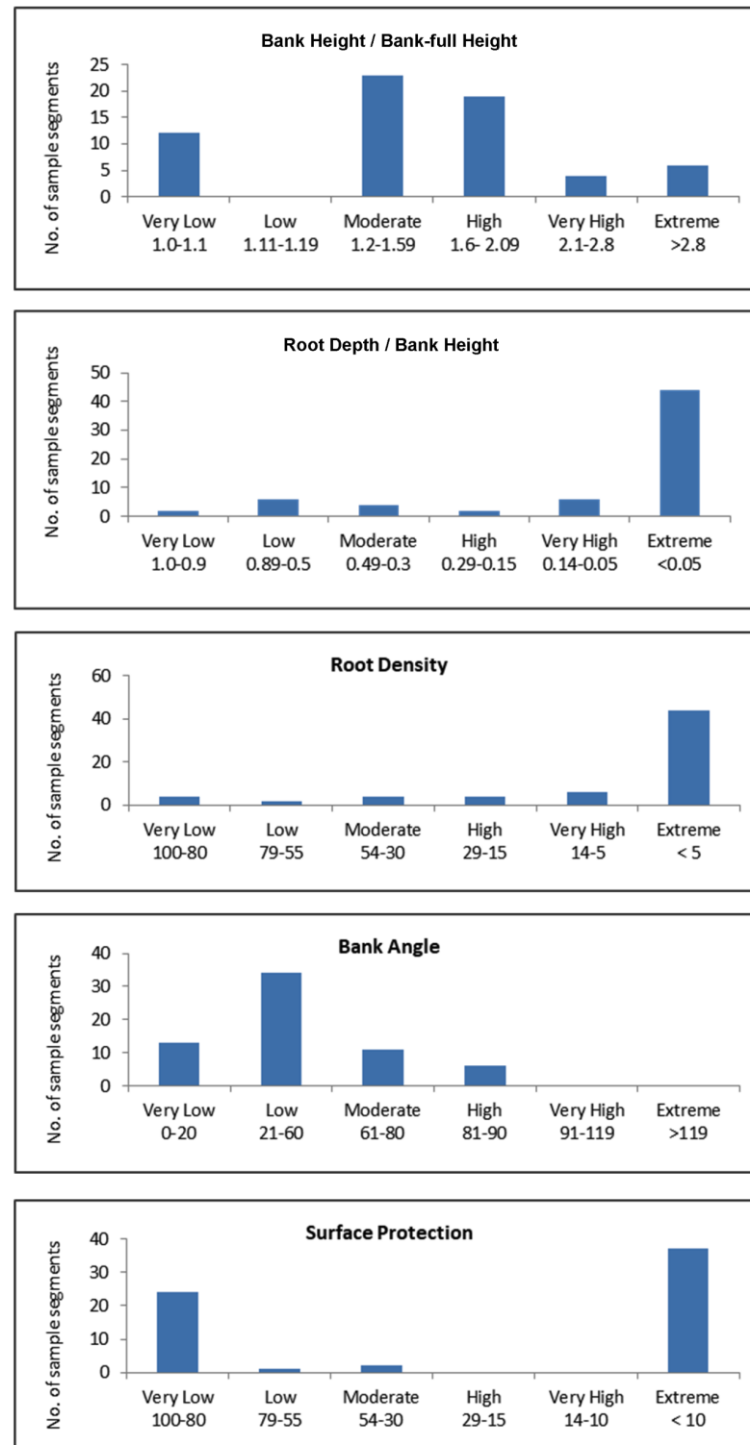
Figure 3. Parameters of BEHI

From the value of bank height and bank-full height ratio, it is clearly found that the ratio is moderate to extreme in most of bank segments due to rise of the water level in the study reach during pick period of monsoon season. Moreover, very low ratio is found only in 12 bank segments (Figure 3A). In case of ratio of root depth and bank height, it was found that maximum segments (44 sample segments) are experienced with less than 0.05. Only two bank segments along the left bank of the Torsa river at the Putimari Baksibas village and Cooch Behar

municipality ward no. 15 attributing the ratio between 0.9-1 (Figure 3B).

In case of root density, 44 bank segments cover below 5%. Maximum (80 - 100%) root density is found in Cooch Behar Municipality ward no. 16 and Putimari Baksibas village due to presence of dense protected forest (Figure 3C). Moreover, 13 bank segments have bank angle between 0° and 20° as well as maximum and minimum bank segments having bank angle between 21° and 60° and 81° and 90°, respectively. Only 11 bank

segments, the bank angle ranges from 61° to 80° (Figure 3D). Most of the bank areas (37 sample bank segments) are covered without any kind of surface protection. 24 bank segments are registered with 80 to 100% surface protection. Most of the bank segments are protected with concrete embankment and boulder netting (Figure 3E). In the study, both sides of the bank are composed of alluvial sand, silt and clay materials. It has also been noticed that the root density and surface protection are high but bank angle is low in most of the cases.

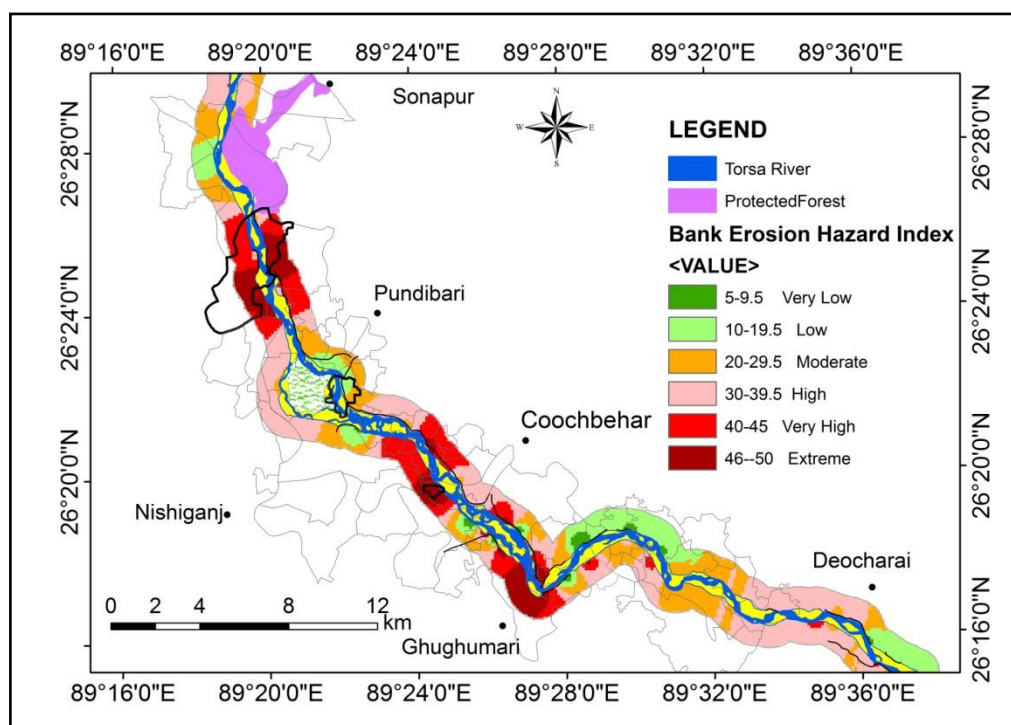
Figure 4. Bank erosion hazard zones

Based on the ratings of above variables and considered BEHI scores for every bank segment, a Bank Erosion Hazard Zone Map was prepared (Figure 4). The result shows that Basdaha Natibari, Salmara Tritiakhanda, Sajherpar Ghoramara, Damodarpur, Karisal and Ghughumari villages are extremely vulnerable to bank erosion hazard due to toe erosion caused due to helical flow. On the other hand, near Patla khawa protected forest and in most of the left bank of the Torsa River vulnerability is low to very low due to presence of riparian vegetation and engineering construction such as embankments, spur, etc. In left bank, due to less surface protections and lack of root density the possibilities of bank erosion are very high to extreme.

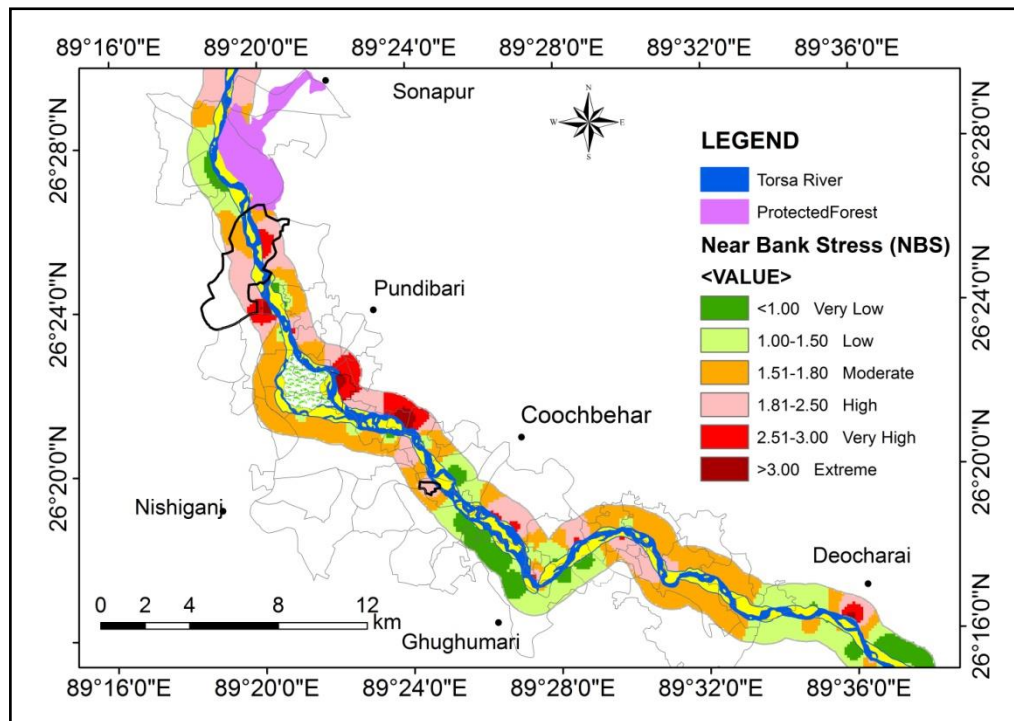
Figure 5. Near bank stress rating zones

River bank erosion is accelerated due to changes of Near Bank Stress (NBS) ratings (Rosgen, 2001a; Ghosh *et al.*, 2016). Based on the field generated data, final NBS rating and rating zone have been determined to assist bank erosion vulnerability (Table 4; Figure 5). Most of the bank segments having high (19 segments) ratio of near bank maximum depth to the bank-full mean depth. On the other hand, 18 bank segments having the ratio of the near bank maximum depth of the bank-full mean depth is low (Table 4). Results show that Basdaha Natibari, Salmara Tritiakhanda, Hariipur, Madhupur, Jatrapur and Deocharai villages are very high to extremely vulnerable to bank erosion (Figure 5). The rest of the bank segment is very low to moderate vulnerability to erosion due to presence of riparian

vegetation and anthropogenic constructions; such constructions are controlling the bank erosion (Figure 5).

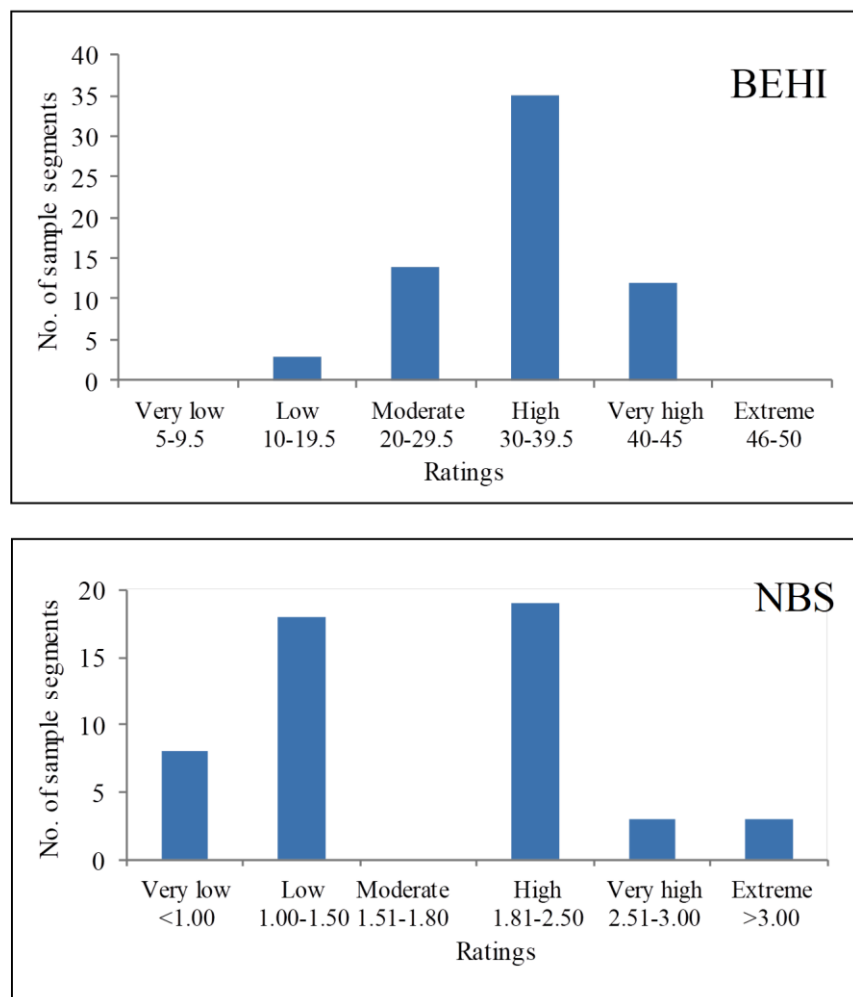
Figure 6. BEHI and NBS distributions

The individual BEHI and NBS ratings have been plotted in Figure 6 from where 35 bank segments indicate high BEHI ratings, 12 segments experience very high BEHI ratings, 14 bank segments belong to moderate BEHI ratings and 3 segments possesses low BEHI ratings (Figure 6; Table 5). On the other hand, out of 64 bank segments only 19 segments possess high category NBS rating, 18 segments indicates the low NBS rating, 8 segments indicate a very low NBS category, 3 segments possess very high category NBS ratings and 3 segments possess extreme category NBS ratings (Figure 6; Table 5).

Correlation between BEHI and NBS ratings along the left and right bank show that the positive correlation, 0.220 and 0.245, respectively. But most of the sample segments as per BEHI ratings are more vulnerable (47 sample segments) to bank erosion than the NBS (25 sample segments) ratings (Figure 6). Out of 64 bank sample segments only 14 segments are perfectly matched with each other. 24 sample segments which are not matched with each other (Table 5). Result of overall lateral stability category shows that the most of the sample bank segments are in unstable condition (Table 5). Torsa River is stabilized along the left bank side due to the presence of dense protected forest and construction of embankment.

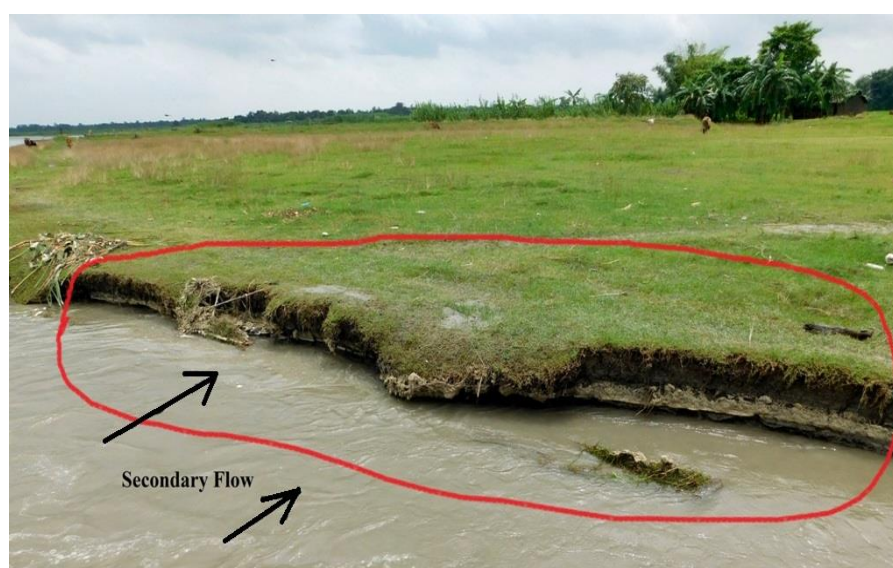
Figure 7. Mechanism of secondary flow to generate bank erosion

BEHI and NBS models, the bank erosion vulnerability study has been made by field verification to estimate the accuracy level. All the data have been derived during the peak monsoon season with the help of GPS survey (Table 8). All the bank segments are found to be more or less unstable condition during monsoon season due to generation of helical flow as well as secondary flow (Figure 7). Primary flow directly attacks the outer bend and secondary flow directly hits at the base of the bank (Figure 7). As a result, the bank materials are removed

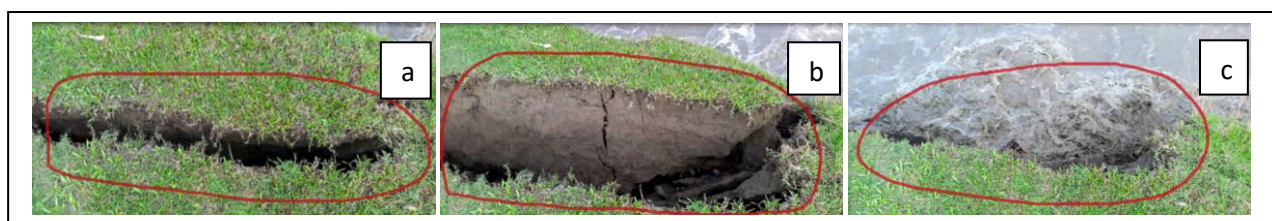
Figure 8. Stages of removal bank material and toppling process

from the base. After removal of the basal support, the bank top is collapsed due to gravitational force and this material are gradually washed away (Figure 8) by steady flow (Maiti, 2016). This type of erosion process is frequently observed in the Torsa river reach. Within a very short span of time, hectares of land regularly erode during monsoon season due to these processes (Table 8). Results of lateral, vertical and overall reach stability show that the stability of the Torsa river reach is widespread unstable in nature (Table 5, 6 and 7). Finally, the stability model has completely been validated with field verification.
